Flashing wood-frame, brick-veneer construction

Detailing and installing flashings properly at the foundation and at openings can help prevent moisture problems

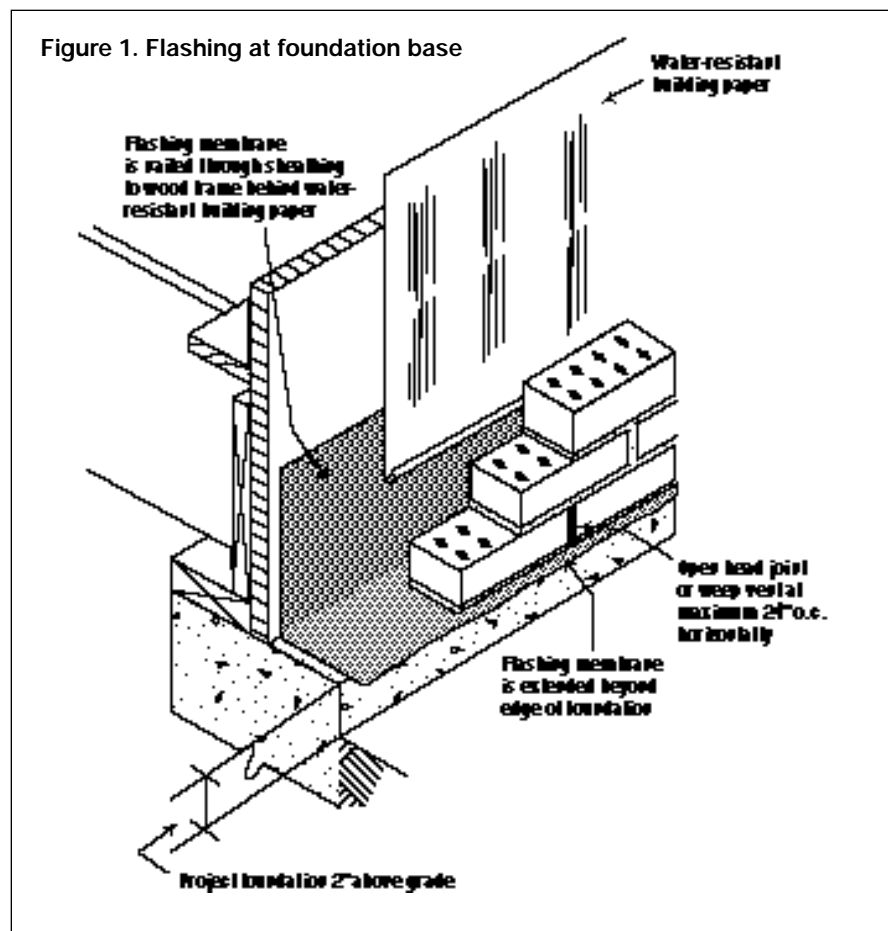
Figure 1 illustrates the proper way to flash the base of a brick-

veneer wall. An oversight that can critically affect wall performance commonly occurs in the handling of the flashing end. The designer must clearly indicate and note on the drawings that the flashing is to be lapped *behind* the water-resistant building wrap or building paper. The flashing

should not be merely nailed to the sheathing over the building paper.

Proper construction prevents moisture that bridges over the air space to the sheathing from flowing behind the flashing, onto the foundation, and into the building. This water infiltration problem is often attributed

Another critical need is to extend the flashing out beyond the exterior wall face. If the flashing stops short of the outer wall face, then water may flow

under the flashing and back into the building.

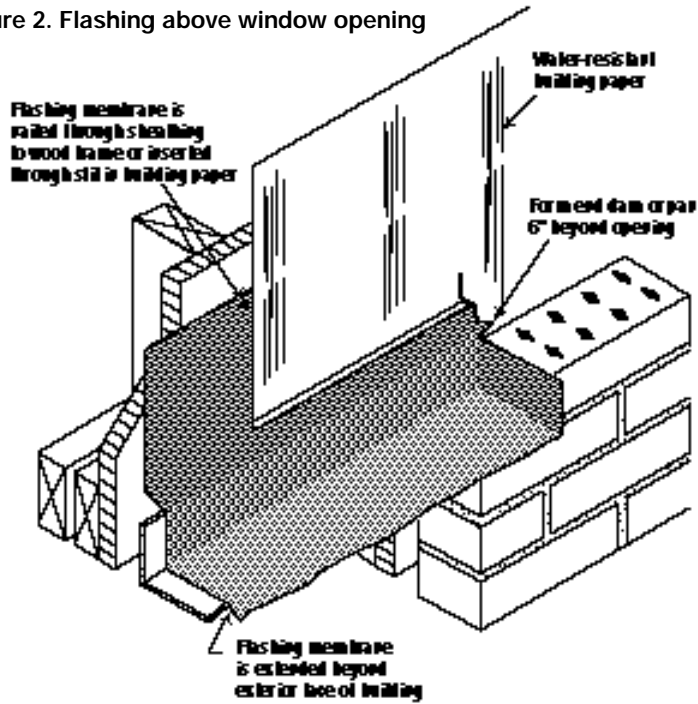
Figure 2. Flashing above window opening

It also is critical for wood-frame, brick-veneer walls to be flashed at openings. Flashing should be detailed both above and below window openings (see Figs. 2 and 3). Designers should note on the drawings the need to form end dams or pans at these locations.

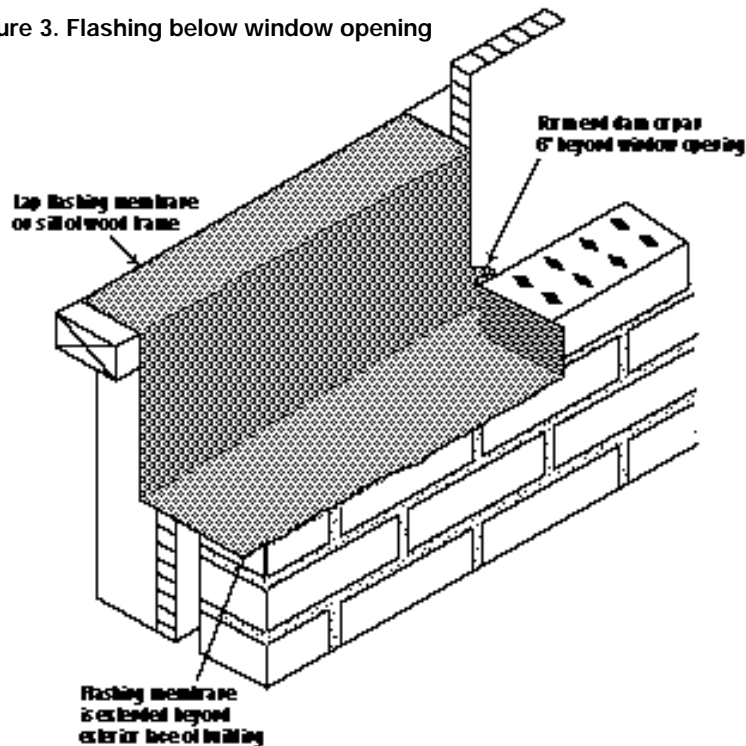
Figure 3. Flashing below window opening
